## **DEPARTMENT OF PUBLIC UTILITIES**

### **PIPELINE ENGINEERING AND SAFETY DIVISION**

## **INCIDENT REPORT**

214 Lunenburg Street, Fitchburg, Massachusetts  
February 5, 2013

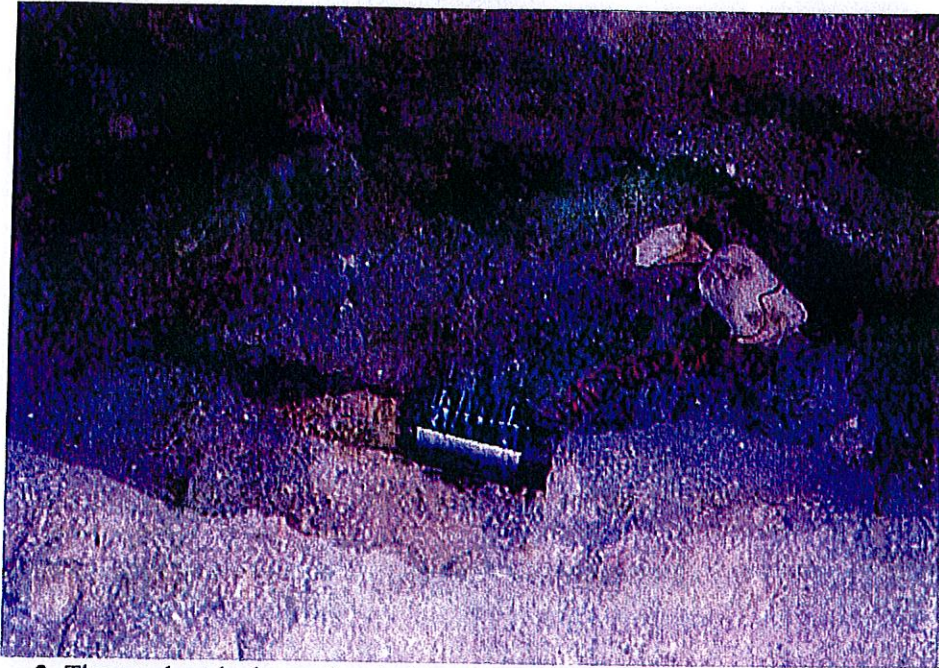
On February 5, 2013, Unitil excavated and exposed the four (4) inch cast iron gas main. A circumferential crack was discovered approximately four (4) feet north of Lunenburg Street. Unitil employees stopped the flow of gas by installing a split sleeve clamp on the four (4) inch cast iron gas main (Exh. 3).

3. The product leak was located, excavated and sleeved.

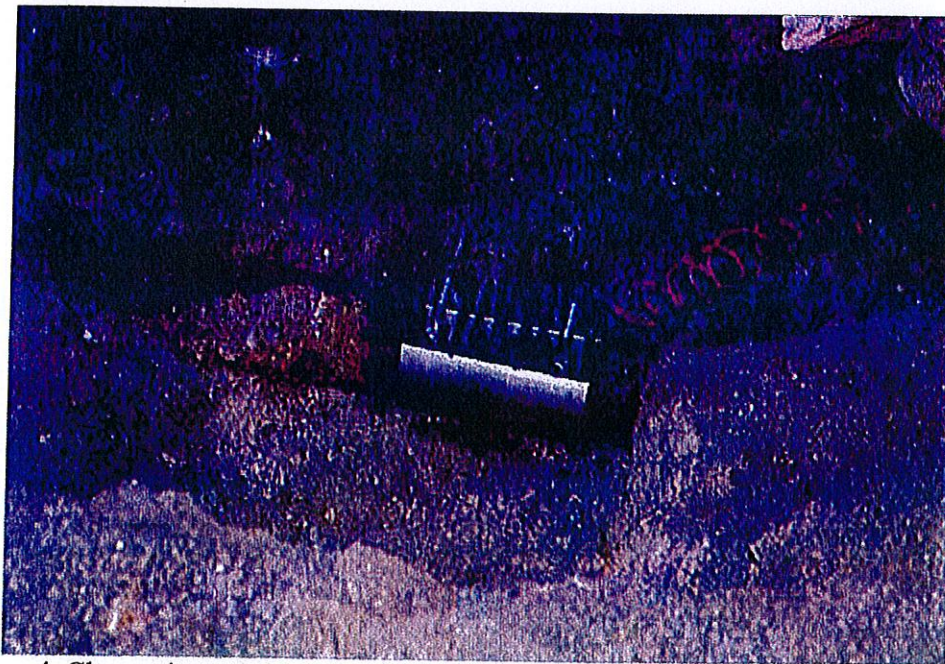
4. Closer view of sleeve patch and ground wire.

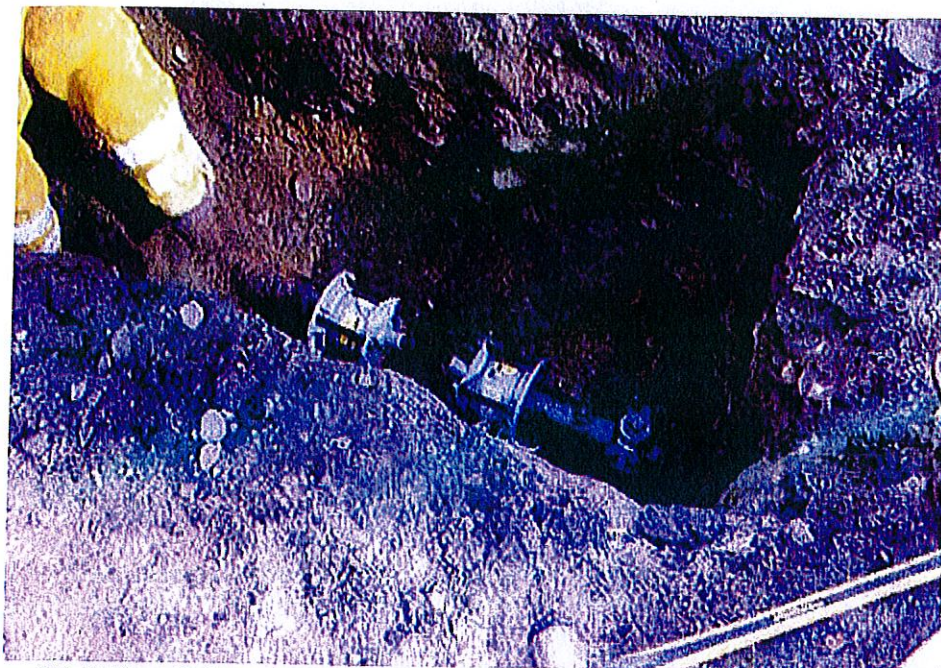
57. Both ends have been capped.

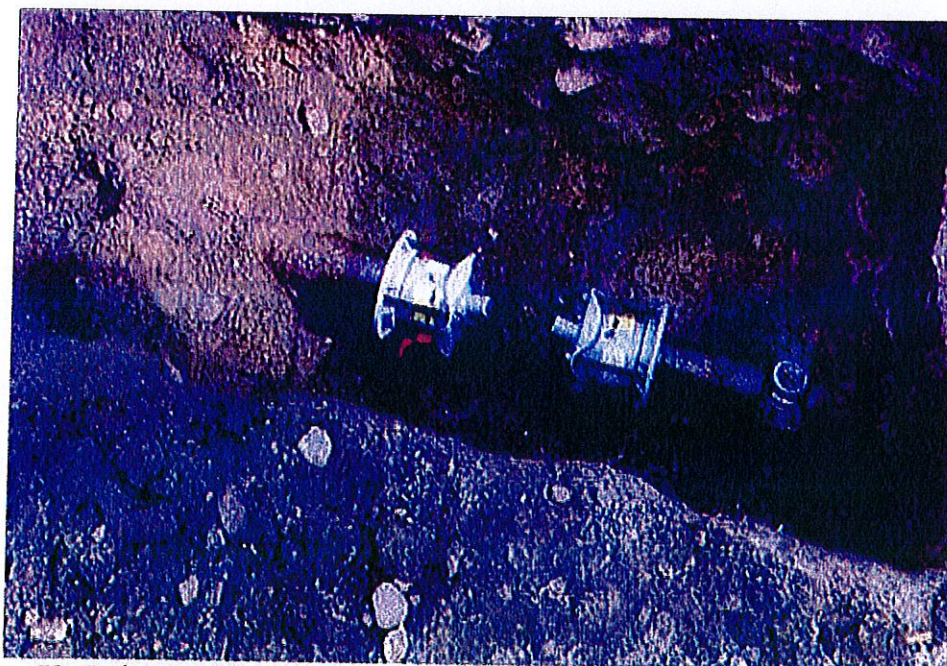
58. Ends capped.

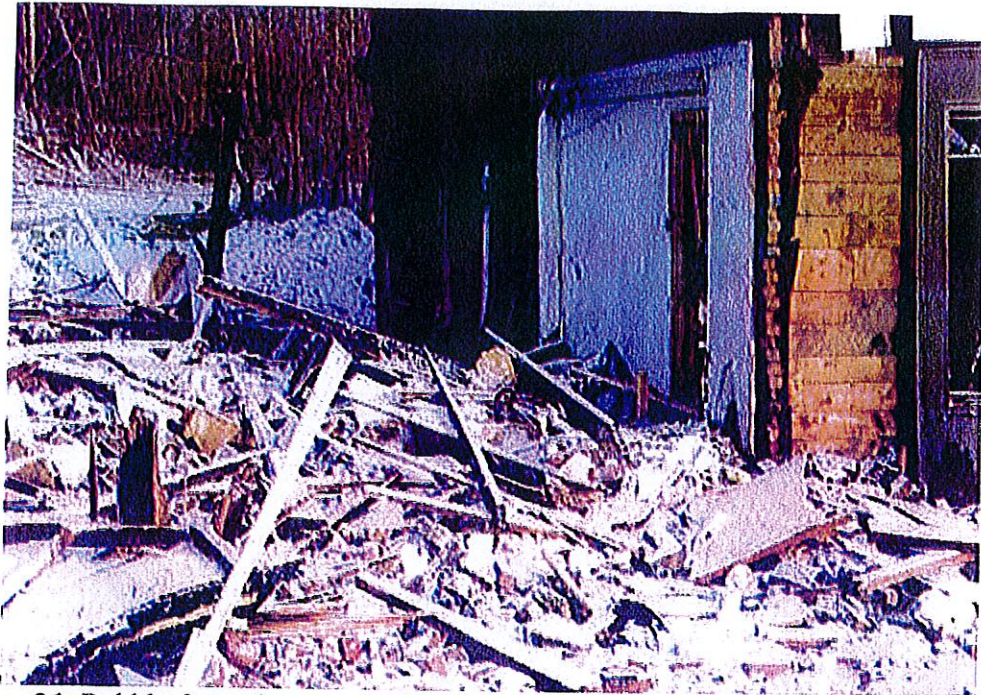
21. Rubble from destroyed addition to auto parts store. (214 Lunenburg Street)

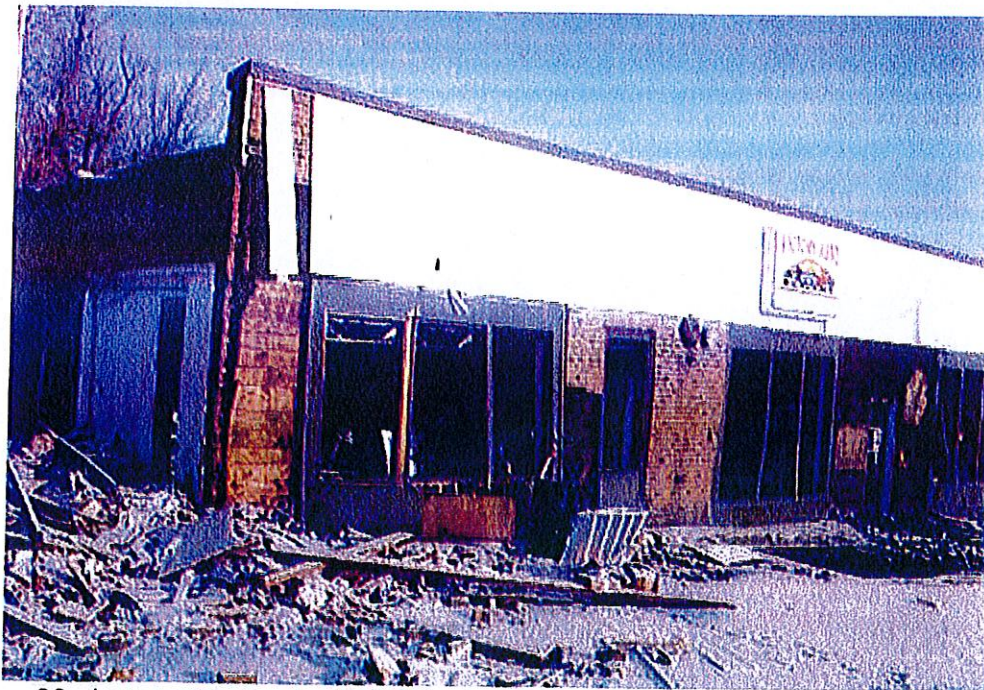
22. Auto parts store in daylight (214 Lunenburg Street)

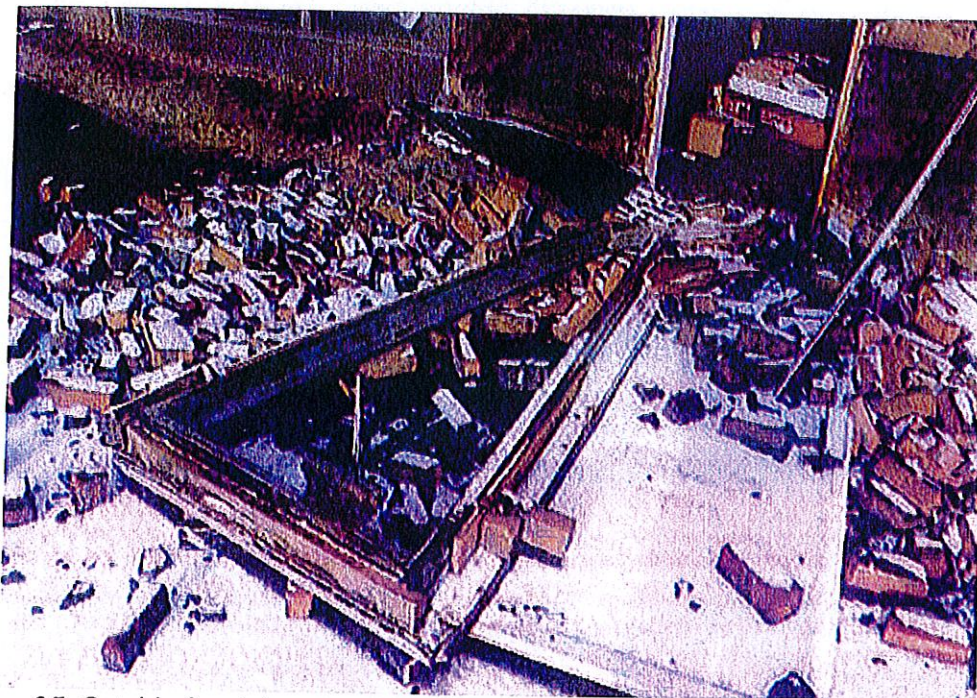
35. Outside front door to store - door frames were blown out and brick veneer had collapsed. (214 Lunenburg Street)

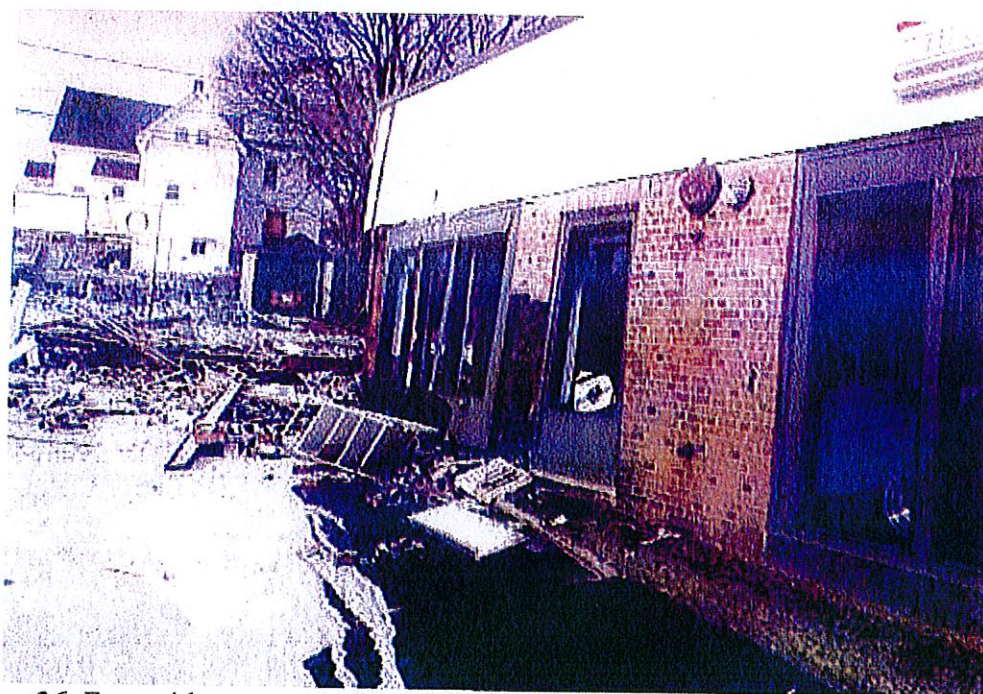
36. Front side. (214 Lunenburg Street)

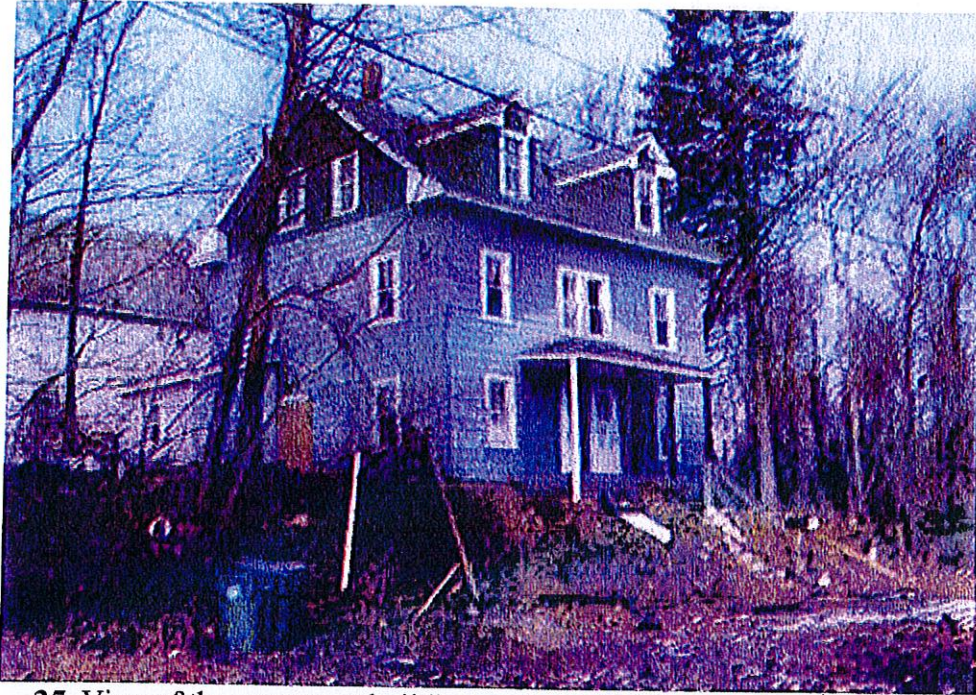
35. View of the apartment building northwest of the scene (5 Linwood Street)

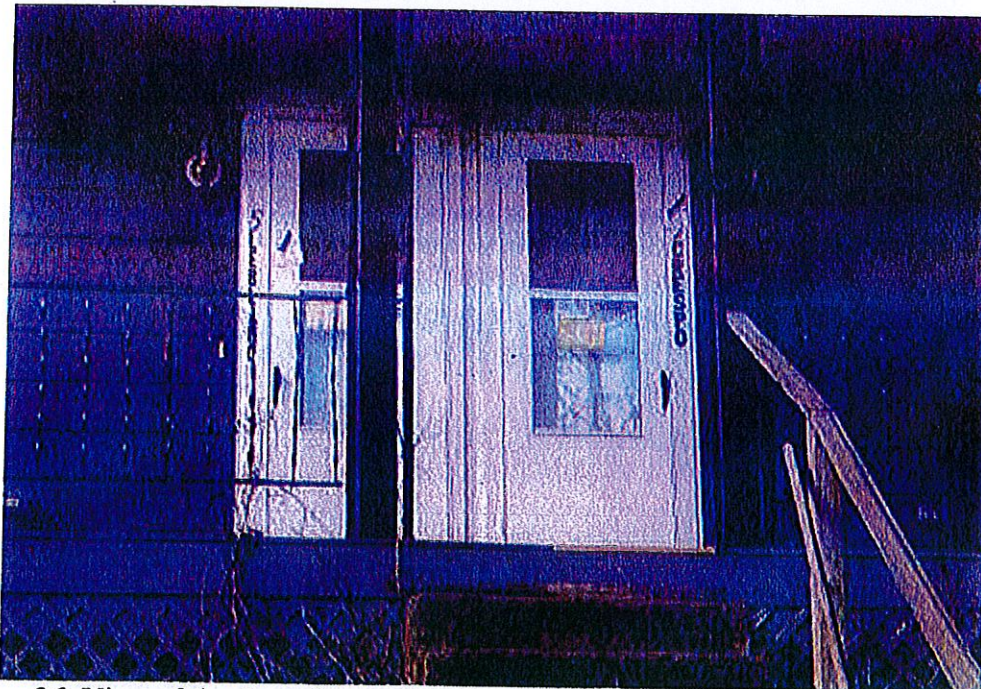
36. View of the front doors with the city placards (5 Linwood Street)

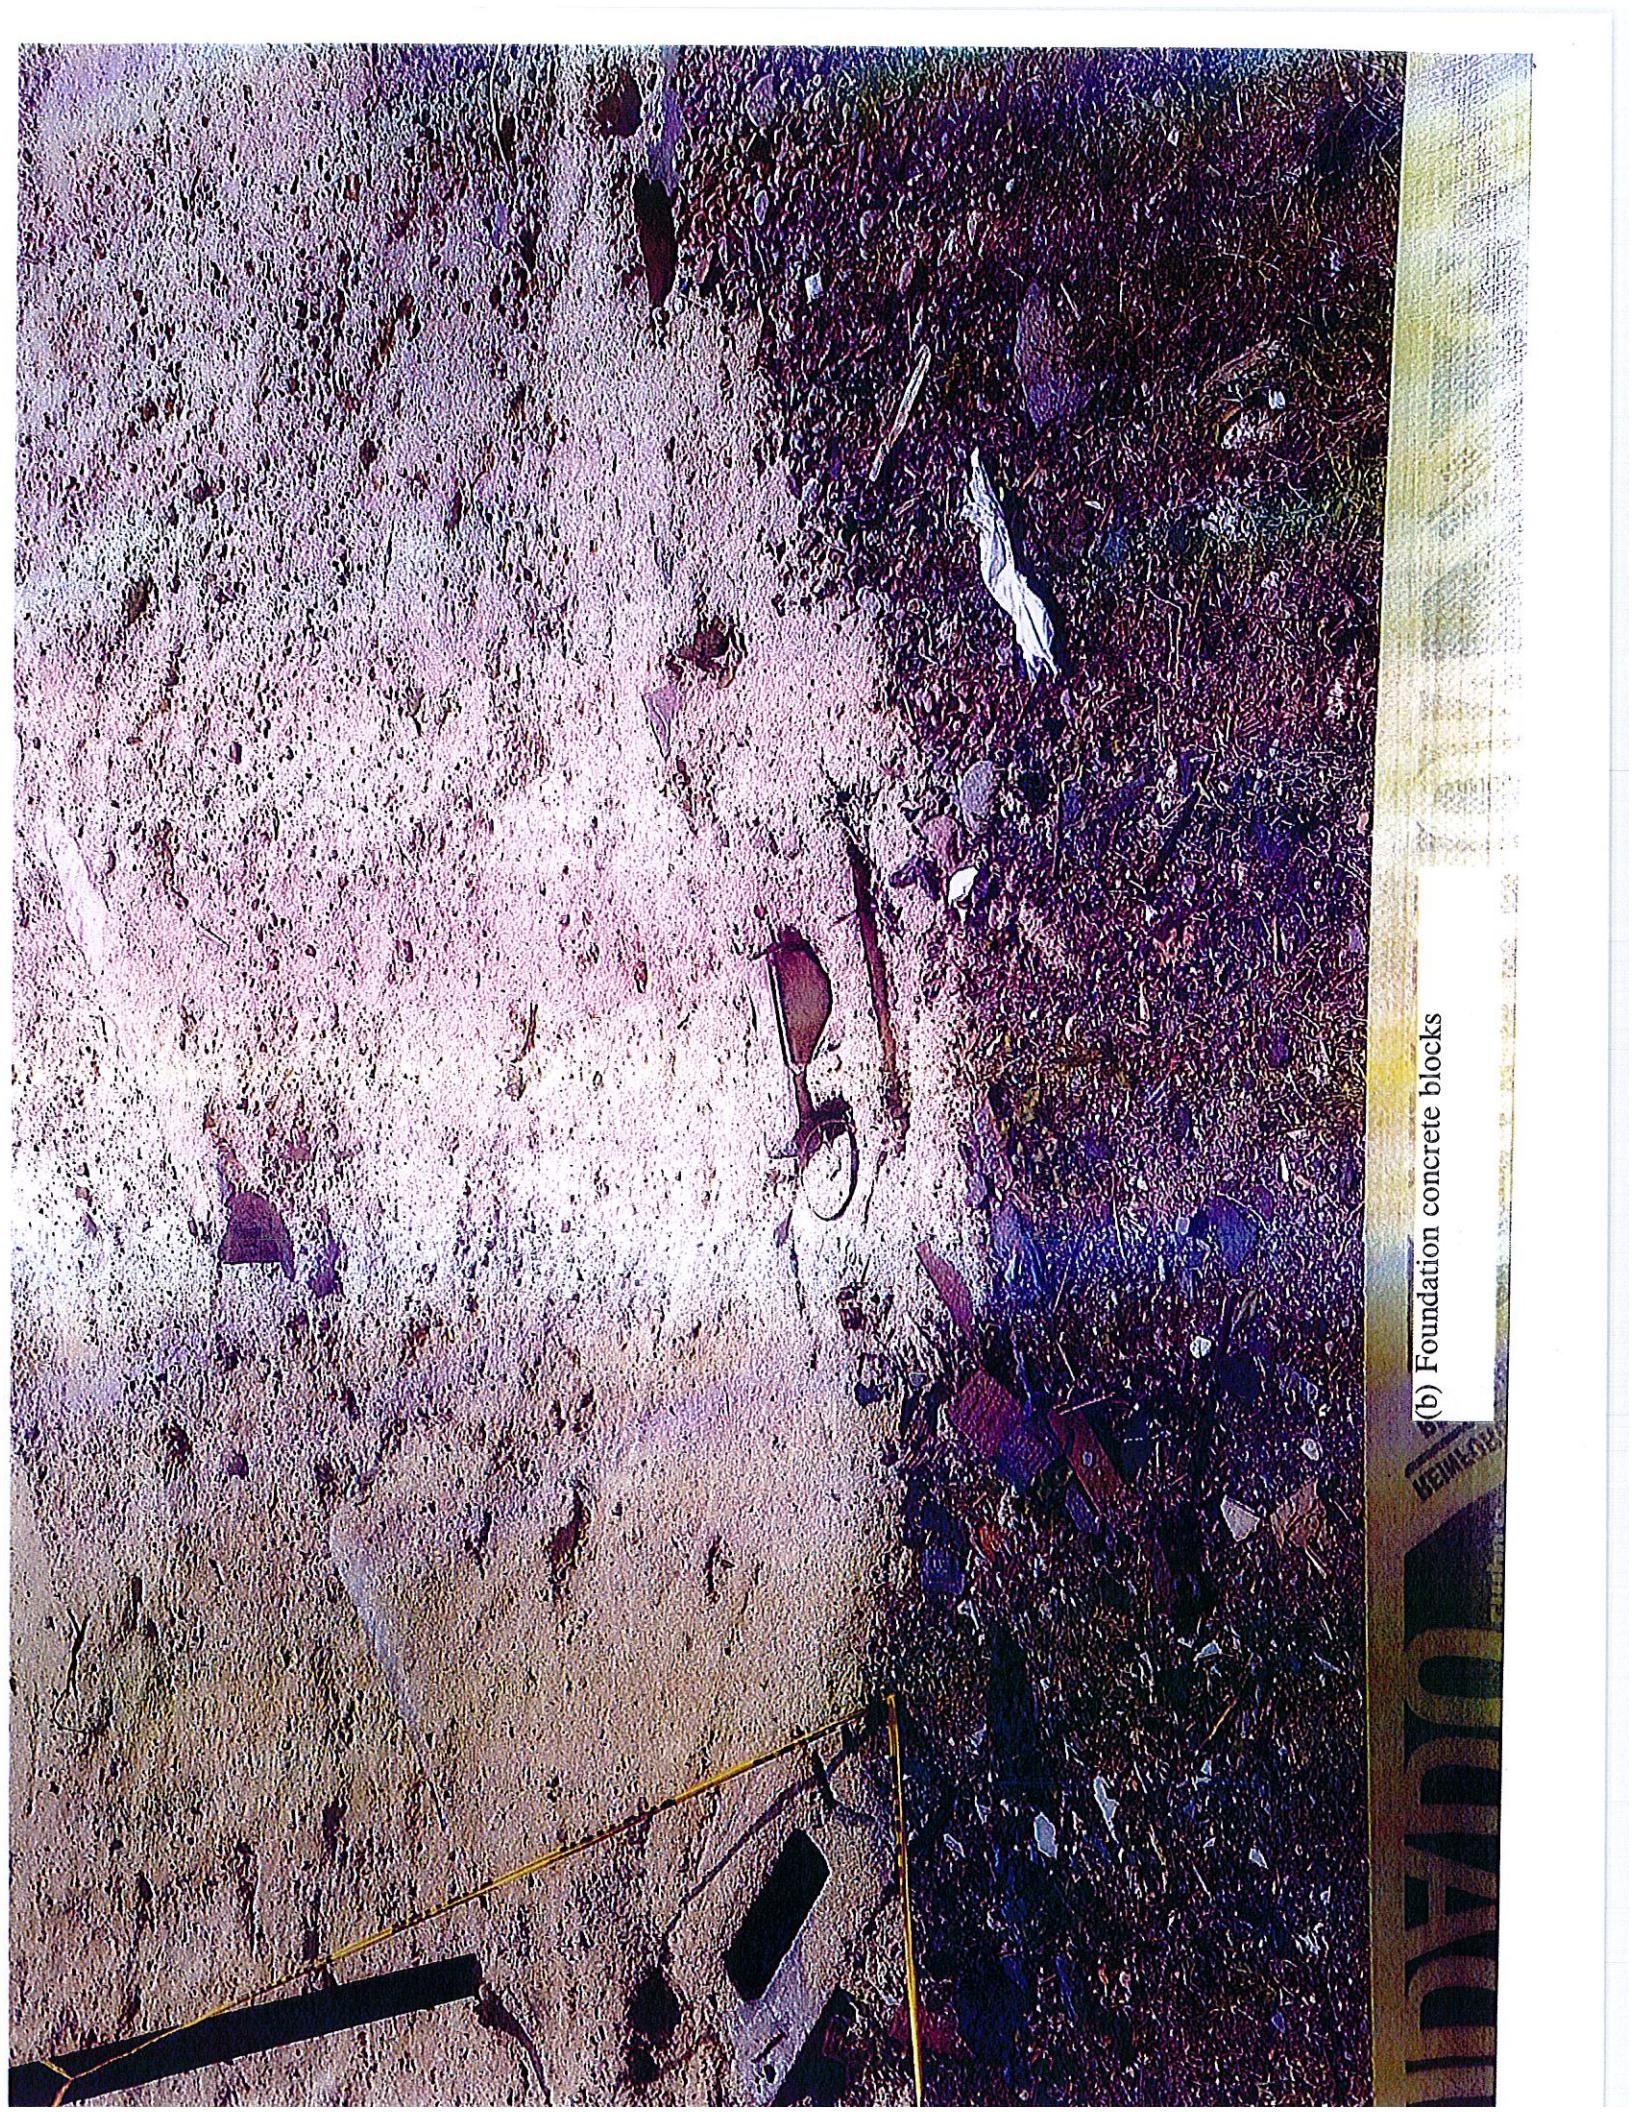
(a) The northwest corner of the foundation of 214 Lunenburg Street, Front

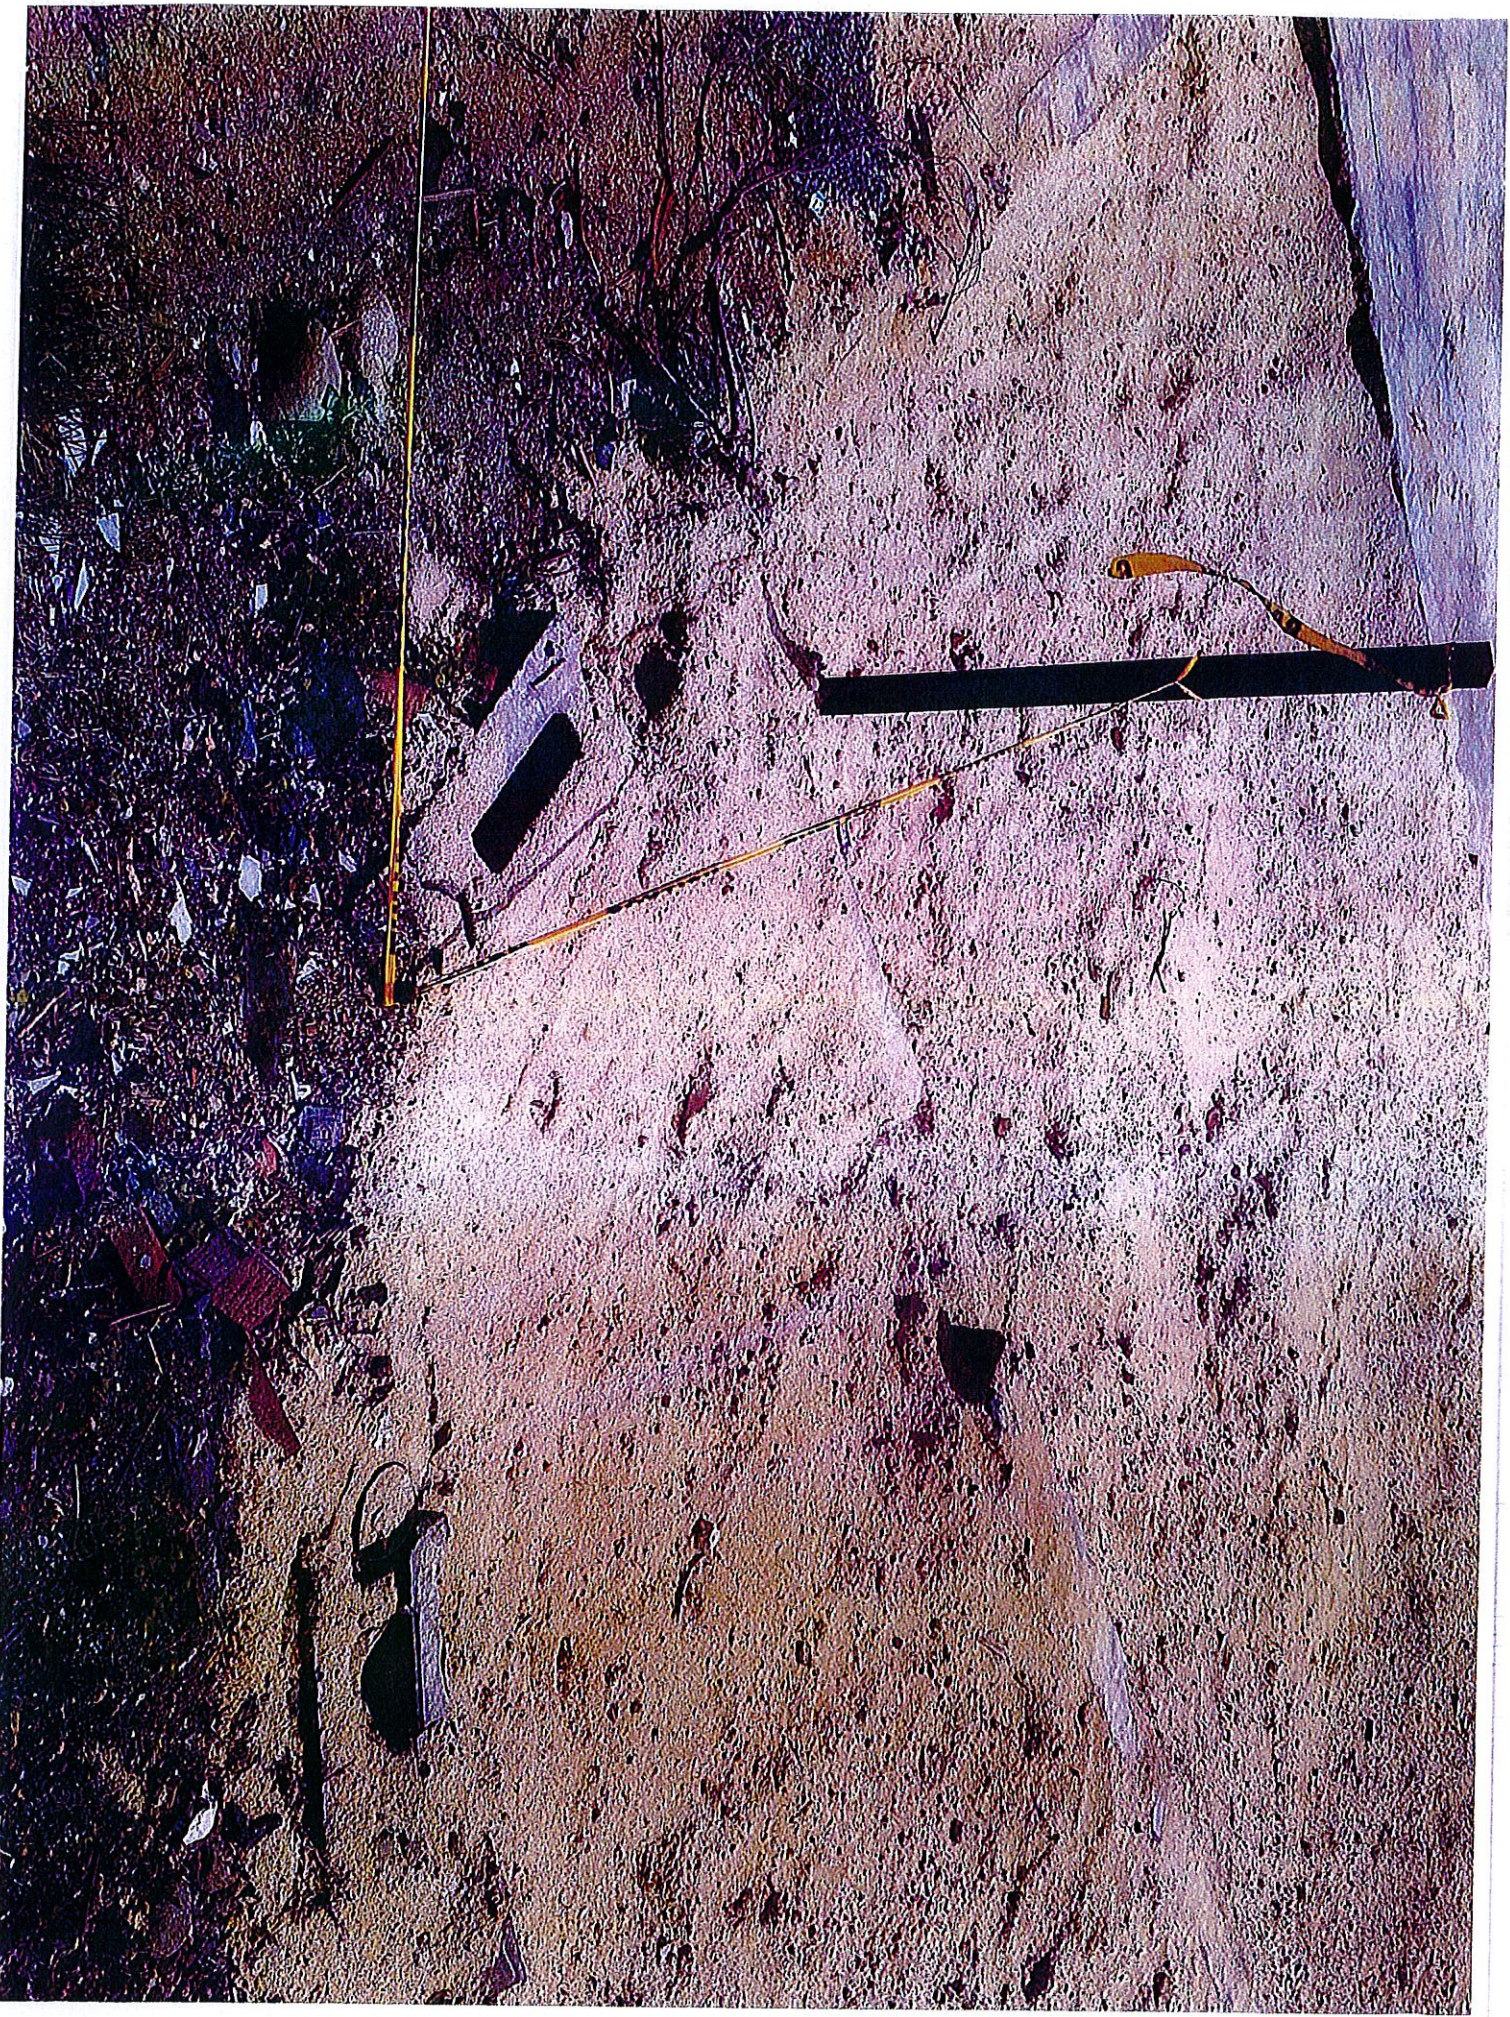
(b) Foundation concrete blocks
